Case Study

AdventHealth Tampa Tampa, FL

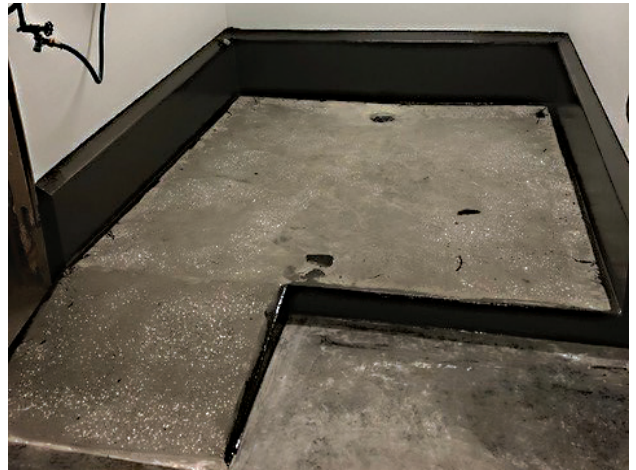
New FRP Panels & Curbing

New FRP panels were installed and the curbing was coated first. The remaining area was then coated and finished. The result was a functional cleaning area with proper drainage and waterproofing that would last for years to come, without causing further damage.

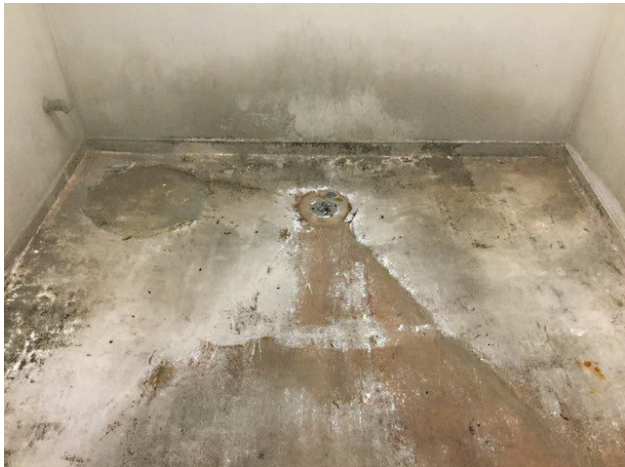
One of these wash down sinks was leaking due to improper drainage and waterproofing. At times it would overflow and/or sit and drain slowly. Standing water had weakened the walls as well as the base of the sink leading to deterioration in both areas.

Preconstruction (wash down area before)

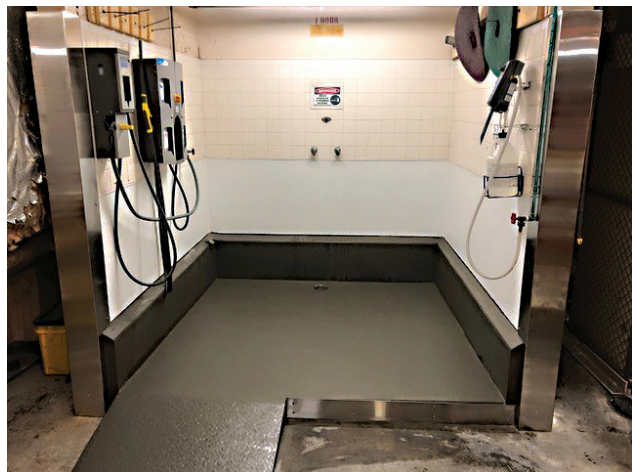
Finished Wash Down Area
