Case Study

AdventHealth Tampa Tampa, FL

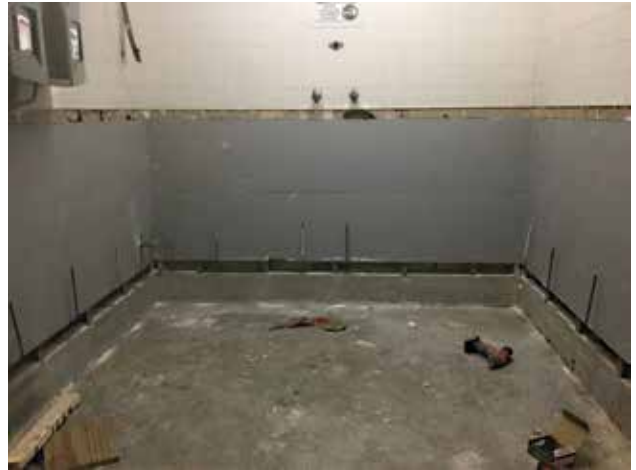
Reconstruction of Walls

Crews began removing the old drywall and any damaged material. They then rebuilt the walls with an extended curb area inside, creating a new interior substrate that would create the needed bathtub effect and protect the walls.

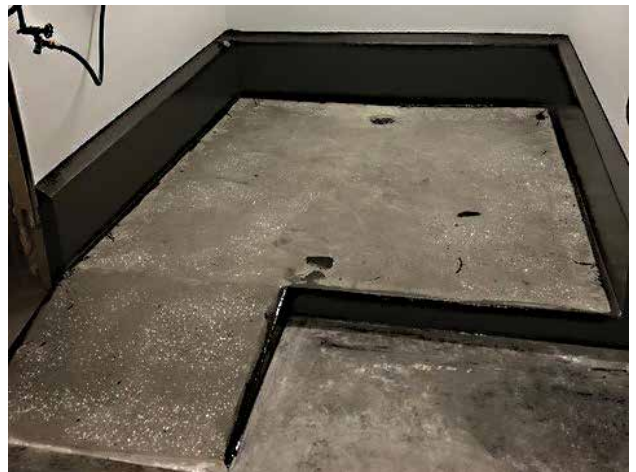
New FRP Panels & Curbing

New FRP panels were installed and the curbing was coated first. The remaining area was then coated and finished. The result was a functional cleaning area with proper drainage and waterproofing that would last for years to come, without causing further damage.

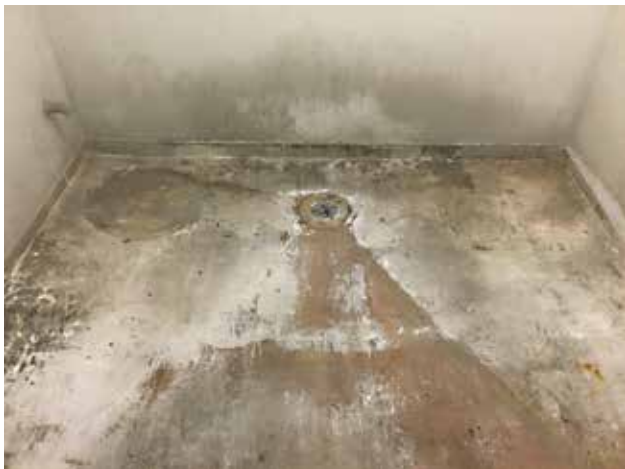
One of these wash down sinks was leaking due to improper drainage and waterproofing. At times it would overflow and/or sit and drain slowly. Standing water had weakened the walls as well as the base of the sink leading to deterioration in both areas.

Preconstruction (wash down area before)

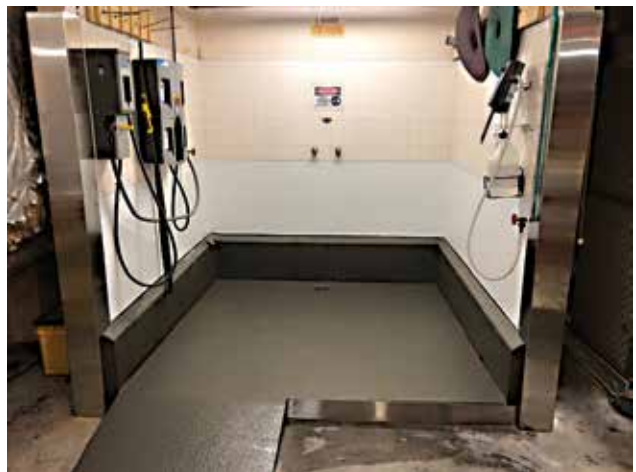
Finished Wash Down Area
