## Case Study

### Kroger On the Rhine Eatery Cincinnati, Ohio

Patterson Floors, LLC  
Carroll, OH

Summer 2020

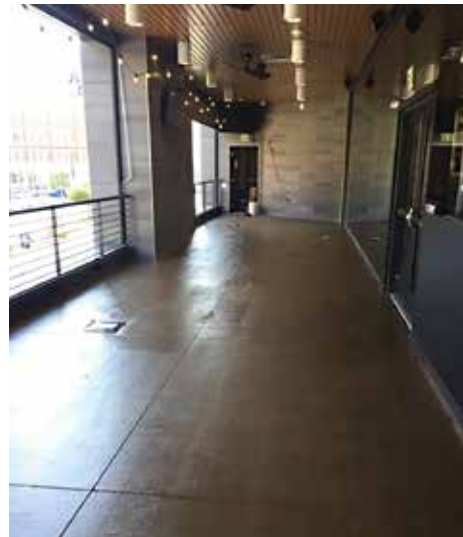
Shortly after opening, it became clear that the lively outdoor patio didn't match the aesthetic of the interior space. Budgeted for plain sidewalk concrete, it was porous and had become stained in just a few months. It needed a coating to improve the look as well as to protect the concrete.

Patio Before (Primed)

Patterson Floors, a Res-Tek certified applicator, recommended Res-Tek's DEK-Guard™ outdoor coating system. Based on methyl-methacrylate (MMA) chemistry, DEK-Guard would be stain-resistant, UV stable to avoid yellowing, and cure quickly to keep patio downtime to a minimum.

The flexible membrane included in this system would also allow for any movement in the patio area, preventing cracks from telegraphing through the surface.

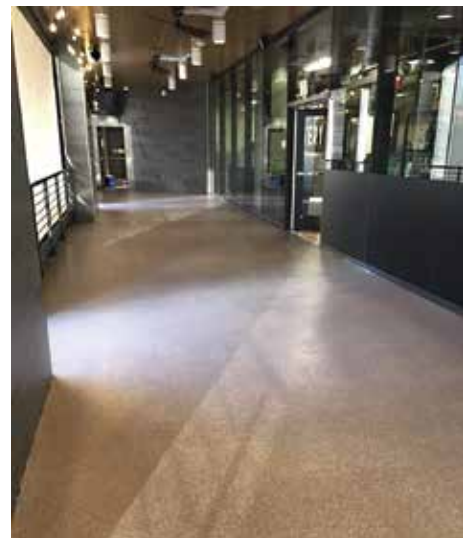
Patio After

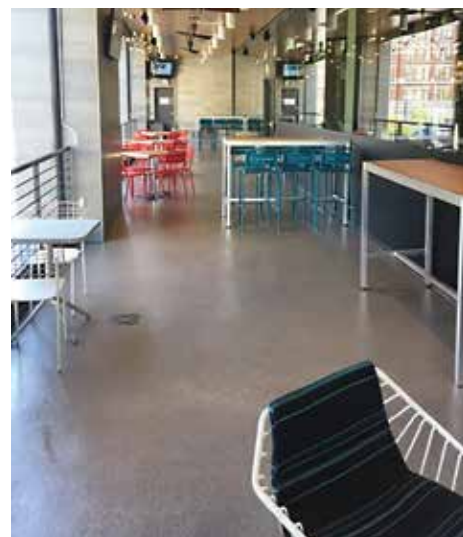
Patio After with Tables
